JOTUN - COATING PERFORMANCE LONG TERM EXPOSURE

Splash Zone Coating Performance Long Term Offshore Exposure

Jotun A/S

Report No.: 2021-3194, Rev. 1

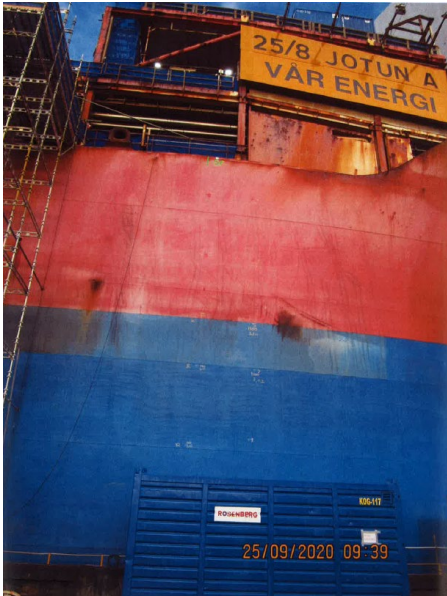
Very few mechanical damages were observed on the hull of the Jotun A FPSO, see Figure 5-1. For the atmospheric zone (red colored Baltoflake) significant chalking due to the exposure of the UV radiation was seen. Jotun A/S states however that this is cosmetic and has no detrimental consequence on the protection properties of the coating. 12 pull-off tests were performed on the hull at different elevations, see Table 5-2.

Figure 5-1 Photos of Jotun A hull starboard side, ref. /13/

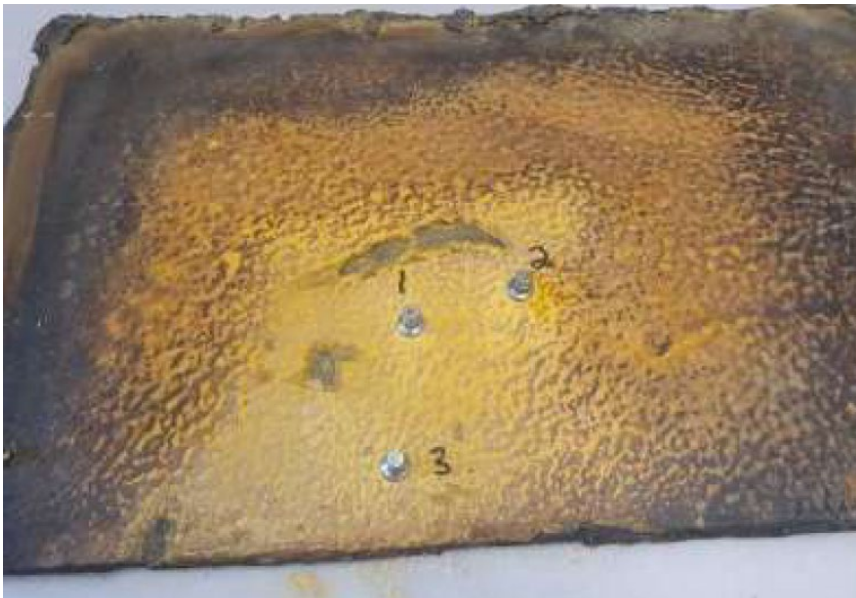
Figure 5-2 Carbon steel sample coated retrieved from atmospheric zone of Ekofisk 2/4A when structure was decommissioned in 2020, ref. /5/. Edges are damaged due to cutting of the sample and center of the sample was used for further examined.

The pull-off adhesion was measured to 5.1 MPa and all three breaks were classified as 100% c-type fracture (cohesive break in the second coat), ref. /5/.

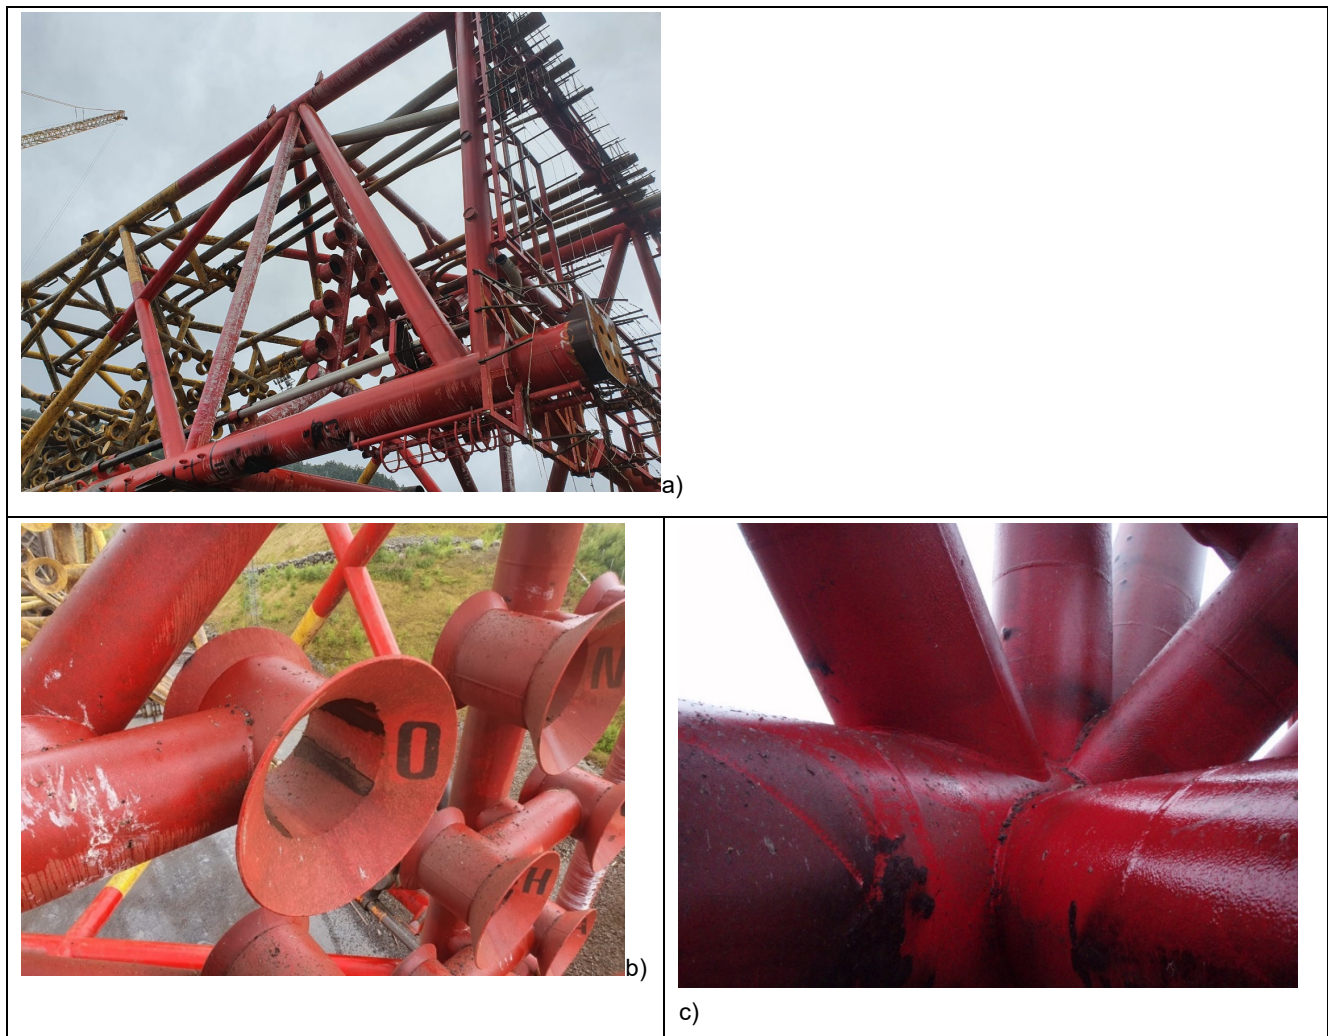
Figure 6-1 Coating appears generally good. a) overview Jotun B at the demolition yard b) conductor frame EL +8 c) node in splash zone, ref. /15/.

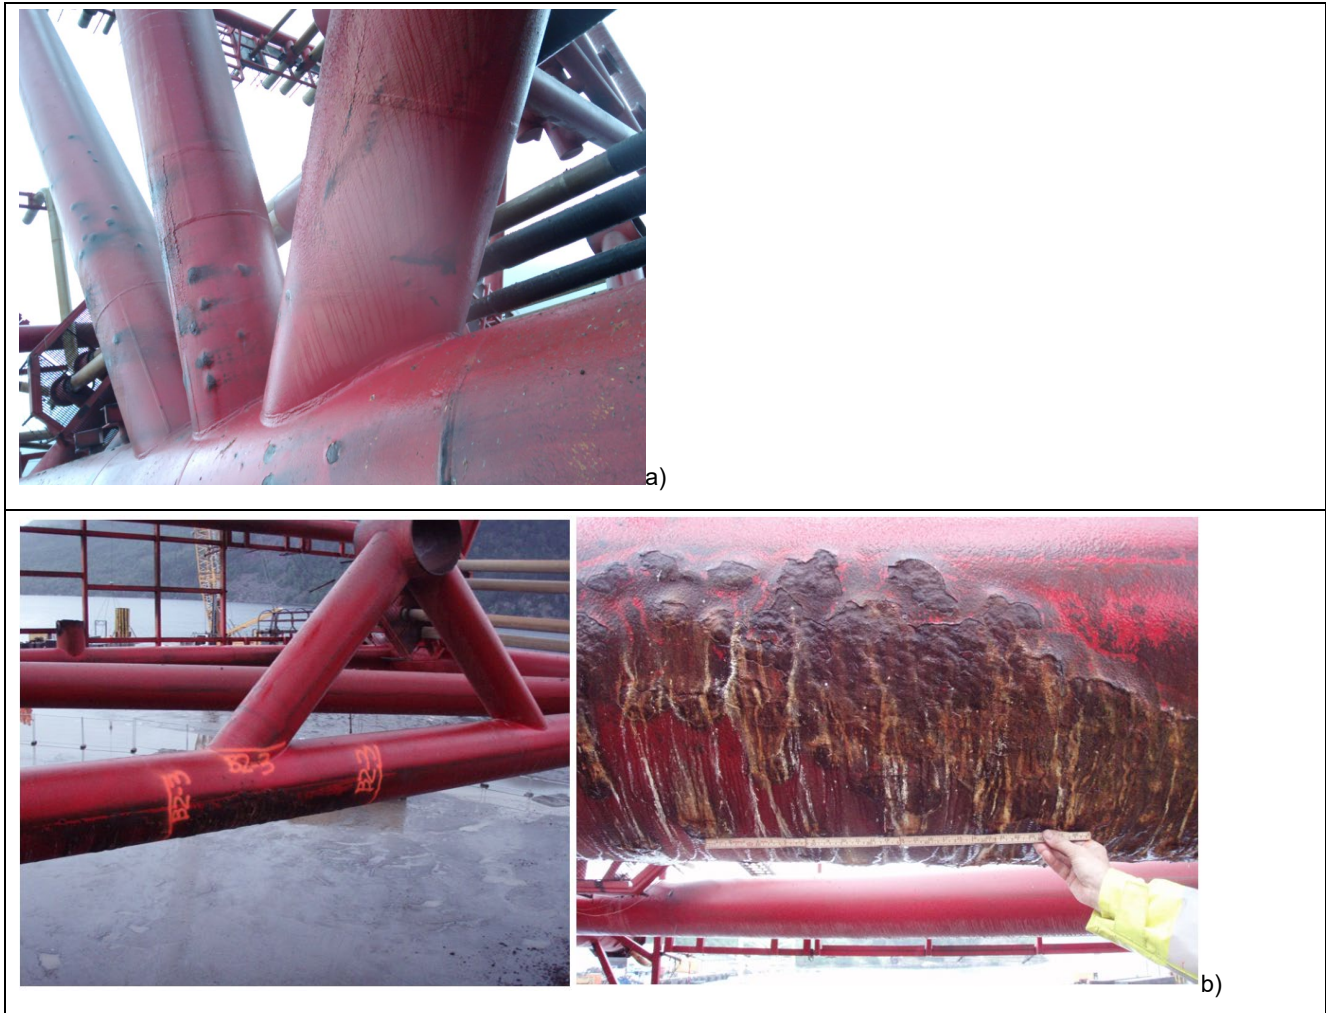
Figure 6-2 A few areas with coating damage at EL +8.5. b) Corroded area further examined with UT and up to 4mm wall thickness reduction was found, ref. /15/.

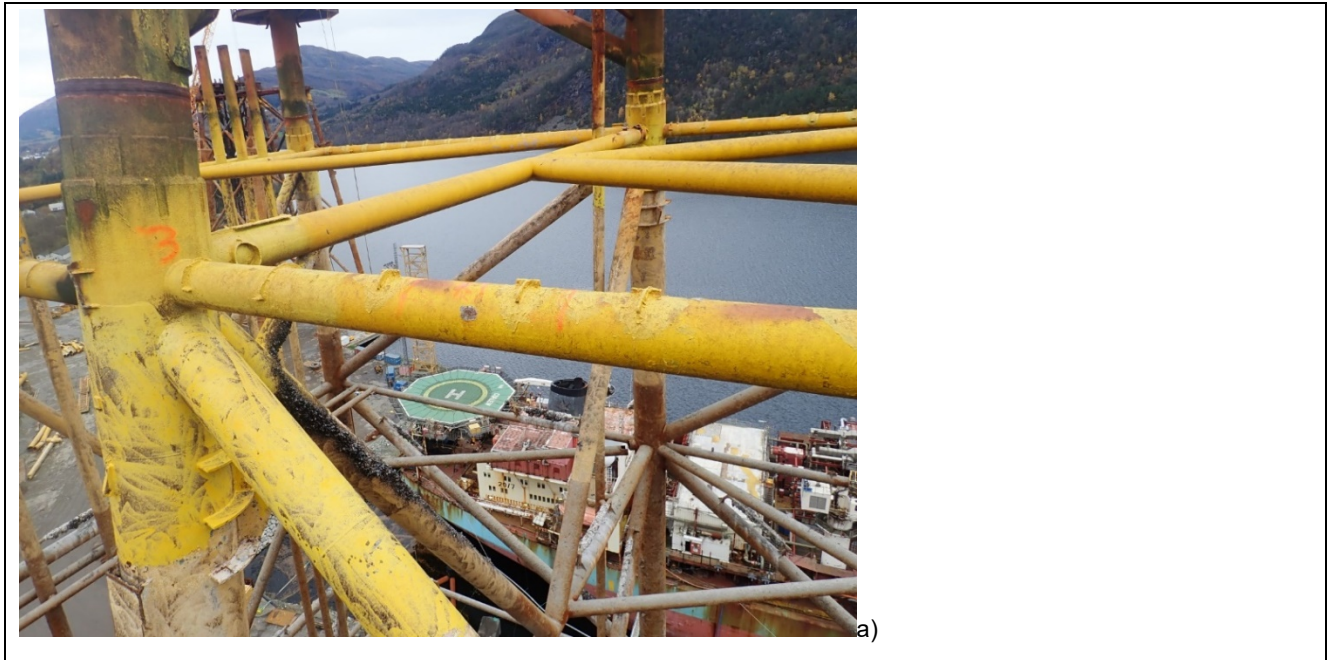
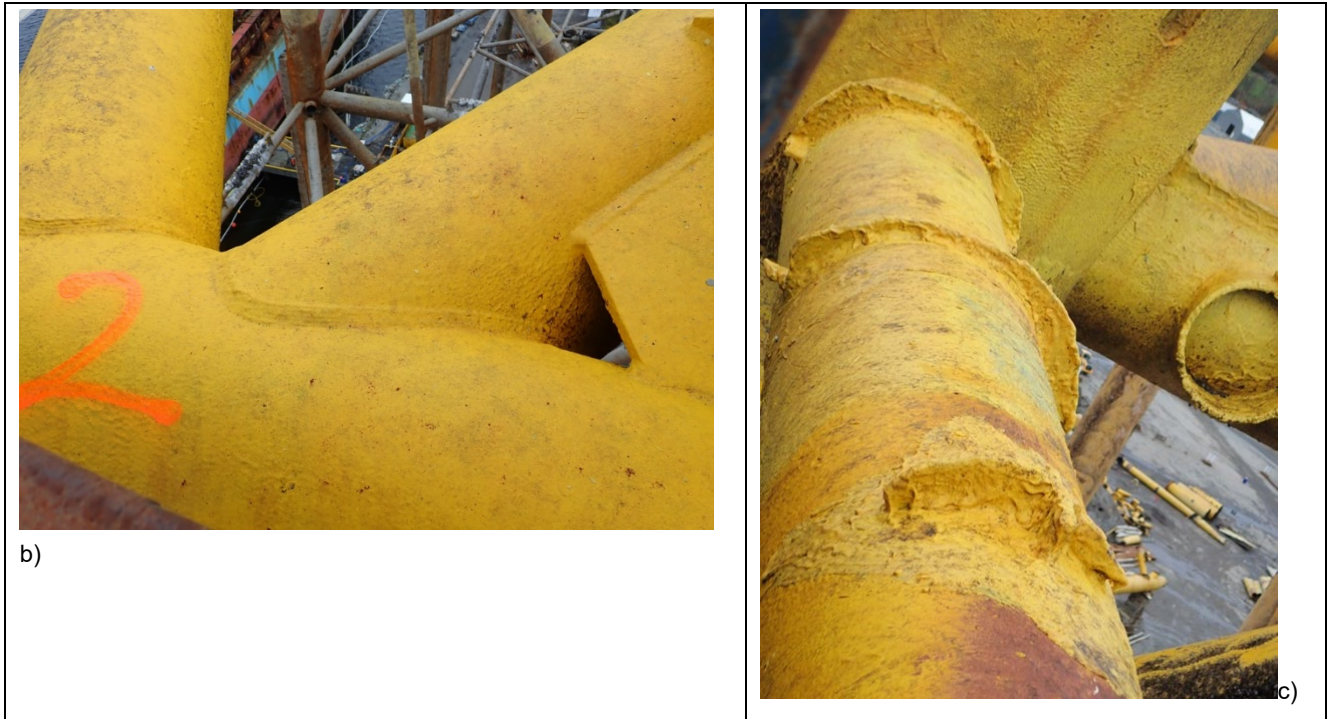
The major areas of coating applied in the splash zone was still smooth, intact and without sign of delamination, see Figure 6-3. Only a few areas of coating damage were found in the splash zone. A coating damage of one of the horizontal braces at EL +20' (+6.1 m) were further examined from ground, see Figure 6-4. The coating was relatively easily removed with a knife in the area close to the coating damage. A reduced wall thickness (WT) of approximately 2 mm was found in the corroded area by UT scanning.

Figure 6-3 Coating appears generally good in splash zone. a) overview El. +20' (+6.1 m) from Row B. b) Close up of node at El. +20' Row 4. c) Close up of node at El. +20' Row A. Some repaired coating on steel inserts (walkway removed in 1993). Ref. /16/.

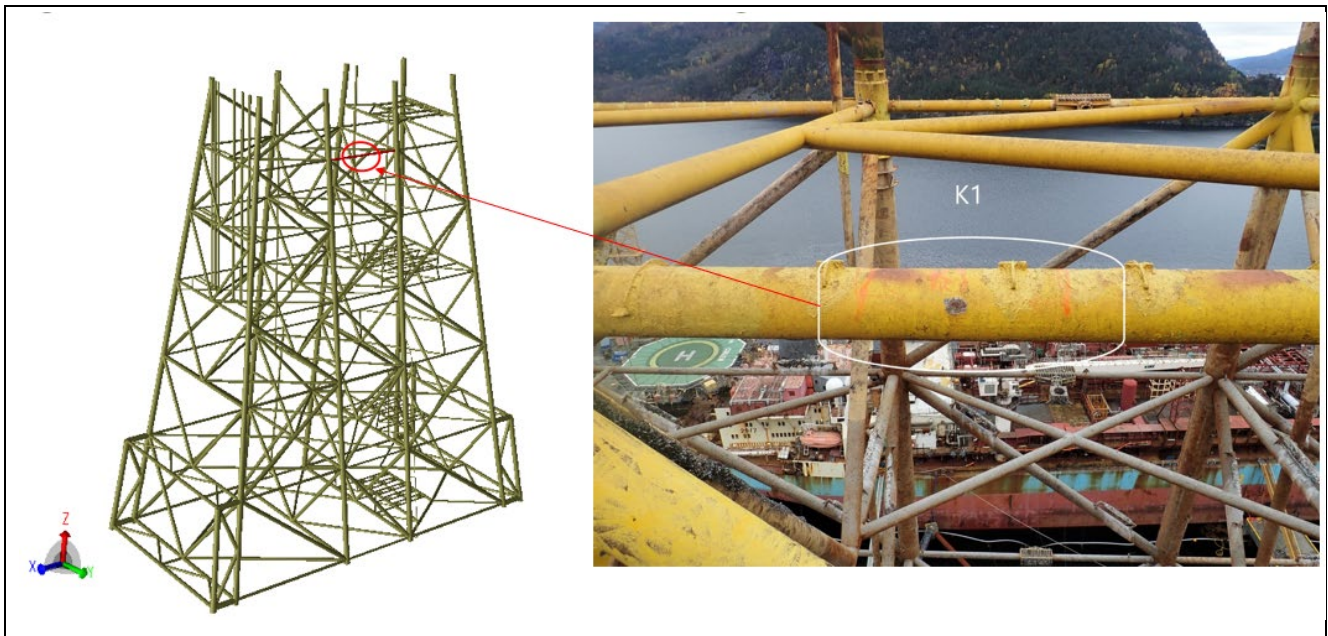
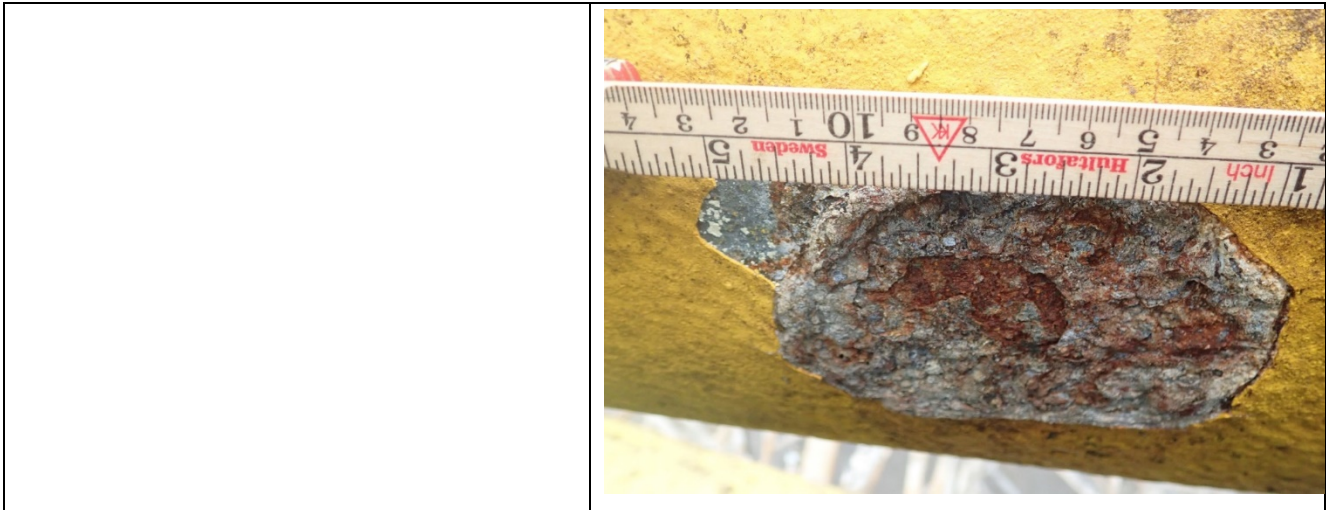
Figure 6-4 Corroded area in splash zone (El. +20'), horizontal brace between leg A2 and leg A3 along Row A, ref. /16/.

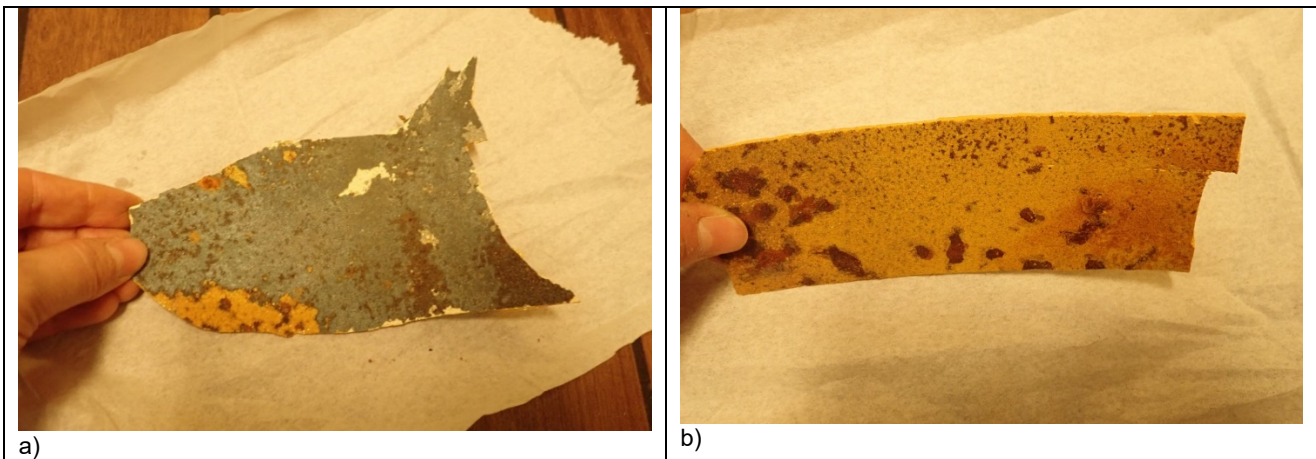
Figure 6-5 Part of underside of flaked off coating from splash zone at EKO, ref. /16/. a) Part of coating close to corroded area shown in Figure 6-4. Note light green primer coating. b) Part of coating from another brace in splash zone. No primer seen on this coating.

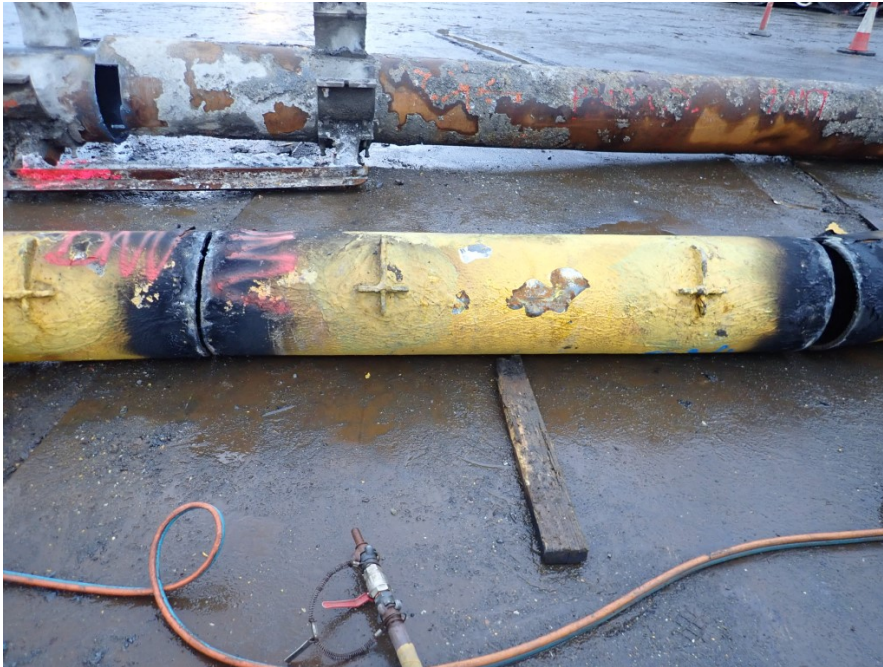
Figure 6-6 2 m length of brace from EL +20' further examined at DNV laboratory in Bergen, ref. /17/.

During the visual inspection of the as-received sample, the coating generally appeared to fit smoothly to a somewhat rugged surface. No blistering, rust, cracks, or other visual defects could be seen in the coated areas without mechanical damage from handling during decommissioning.

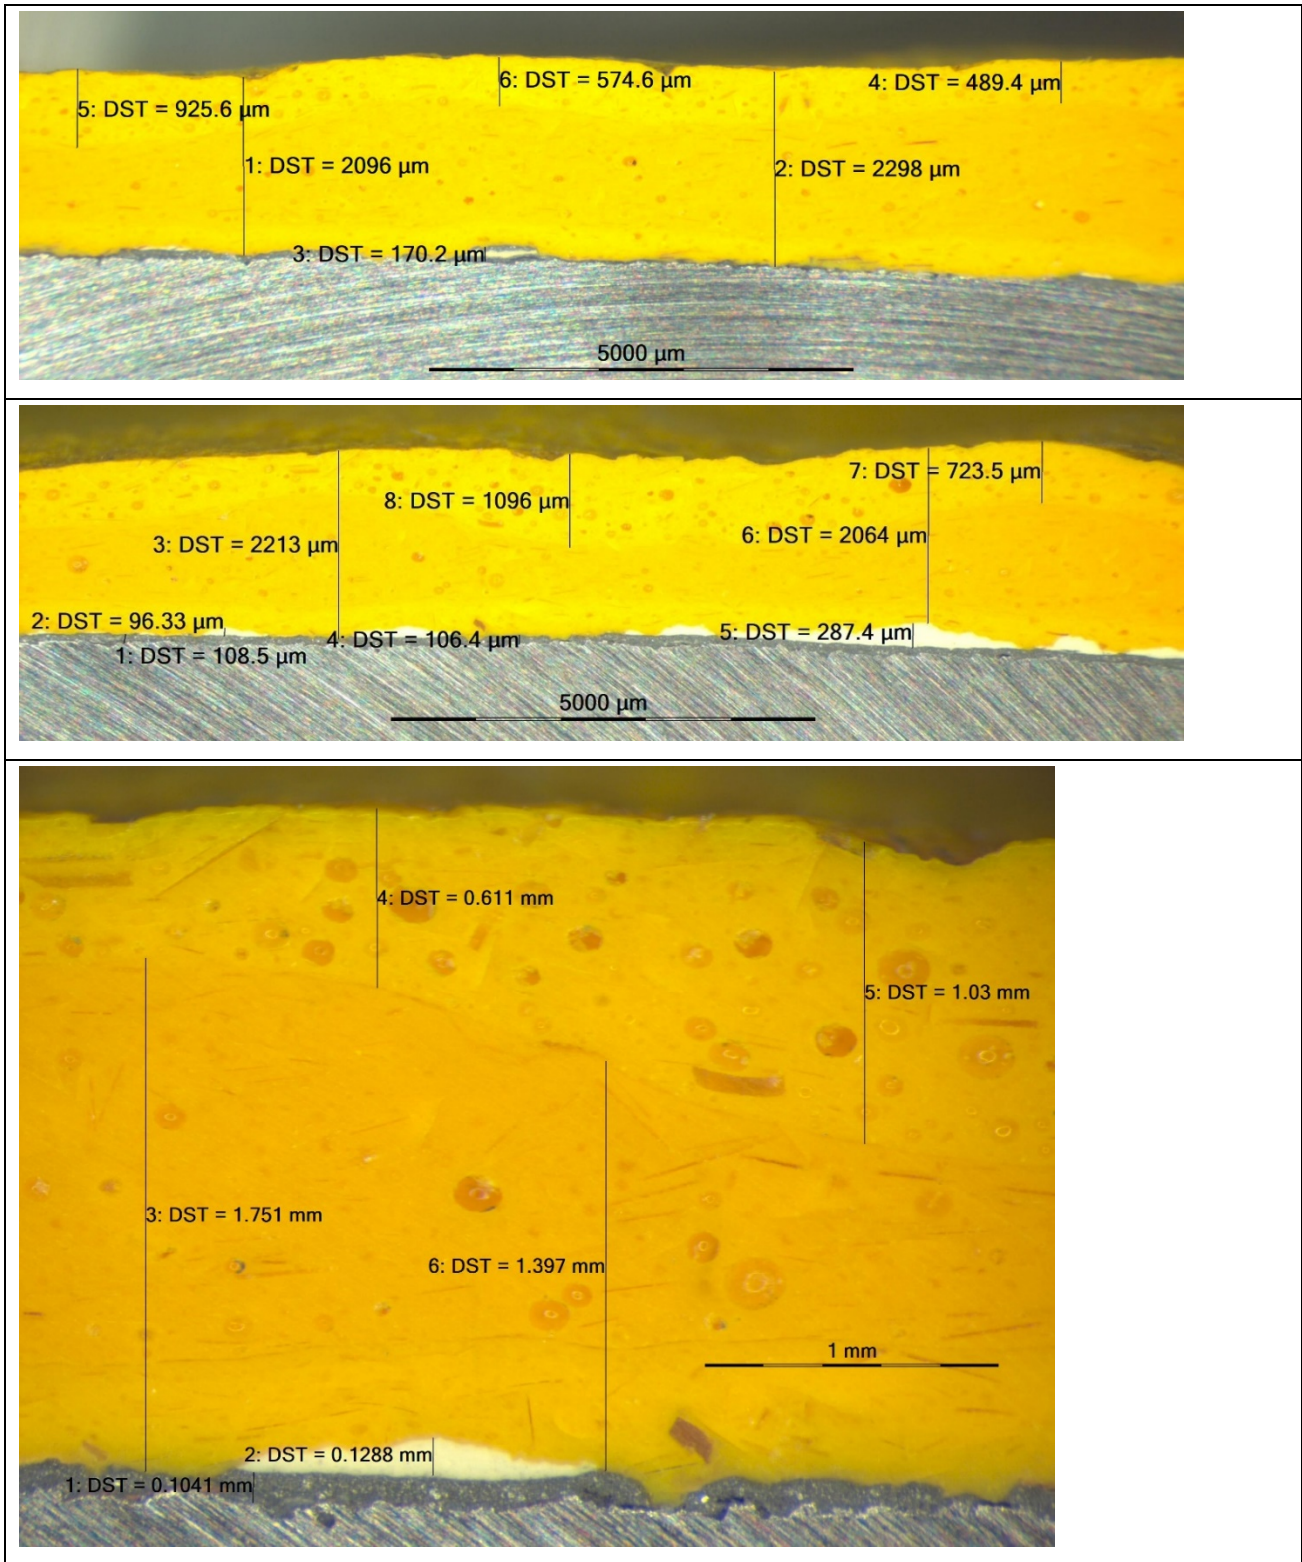
Figure 6-7 Picture of sample 'C' in Table 6-1, taken with 10X and 40X magnification, ref./17/.

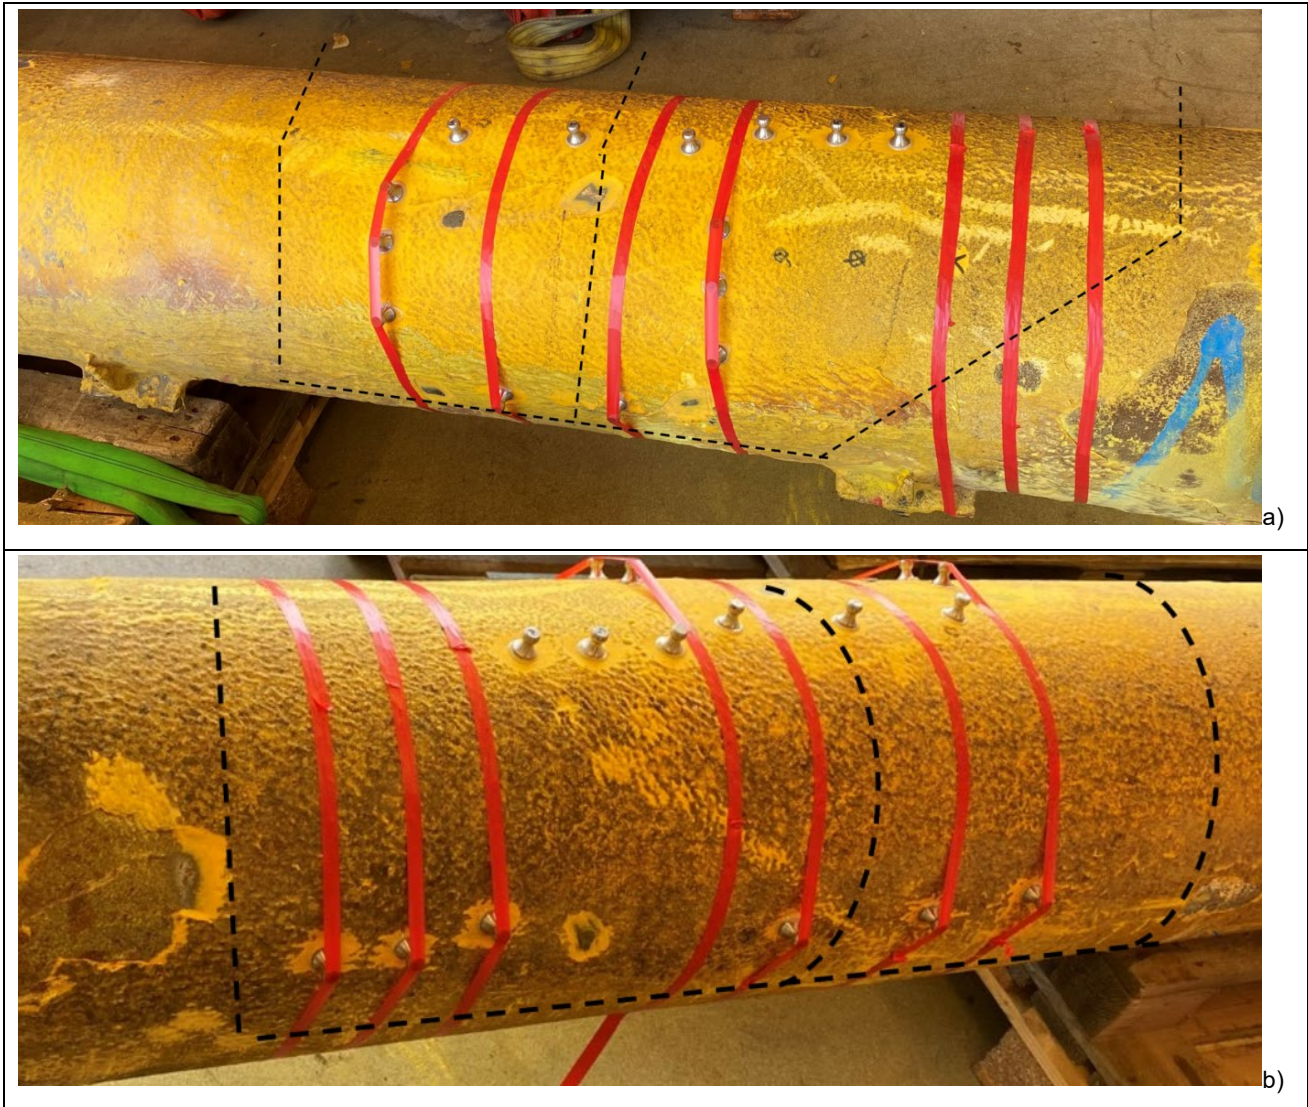
Figure 7-1 a) Received brace after dollies for pull off adhesion test were attached. Area for cutting is marked by dotted lines (right section was kept at DNV while left section was sent to Jotun A/S). b) Opposite side of brace (left section was kept at DNV while right section was sent to Jotun A/S), ref. /1/.

Results from the pull-off tests showed an adhesion strength of 1.3-6.1 MPa, see Table 7-1. Most of the fractures were cohesive. Some corrosion products could also be seen on some of the surface with adhesive failure partly between steel and the coating, see Figure 7-2. Jotun A/S supplied a sample of Baltoflake Ecolife (today's version of Baltoflake) which was applied on top of the existing coating (to simulate repair). No mechanical preparation was done to the existing coating prior to application. Adhesion testing with pull-off method revealed that the re-coated area had an adhesion strength of 1.2 - 5.7 MPa and most of the fractures were cohesive. Some of the fracture (2 of 6 samples) was also adhesive failure between original coating and the Baltoflake Ecolife.

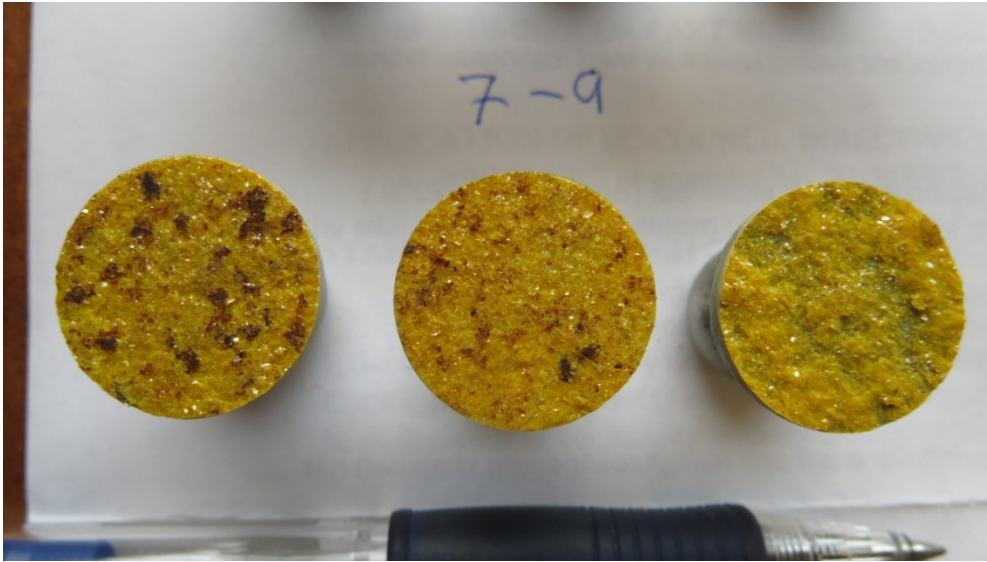
Figure 7-2 Surface of dolly 7, 8 and 9 in Table 7-1 after pull-off, ref. /1/.

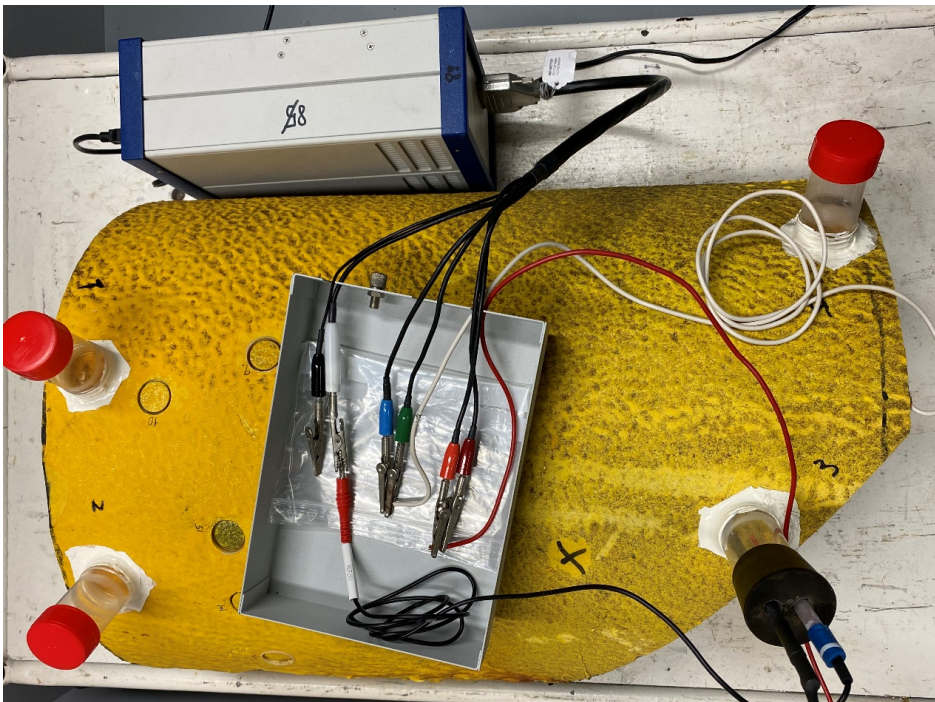
Figure 7-3 Photo of the 4 locations for EIS measurements, ref. /1/

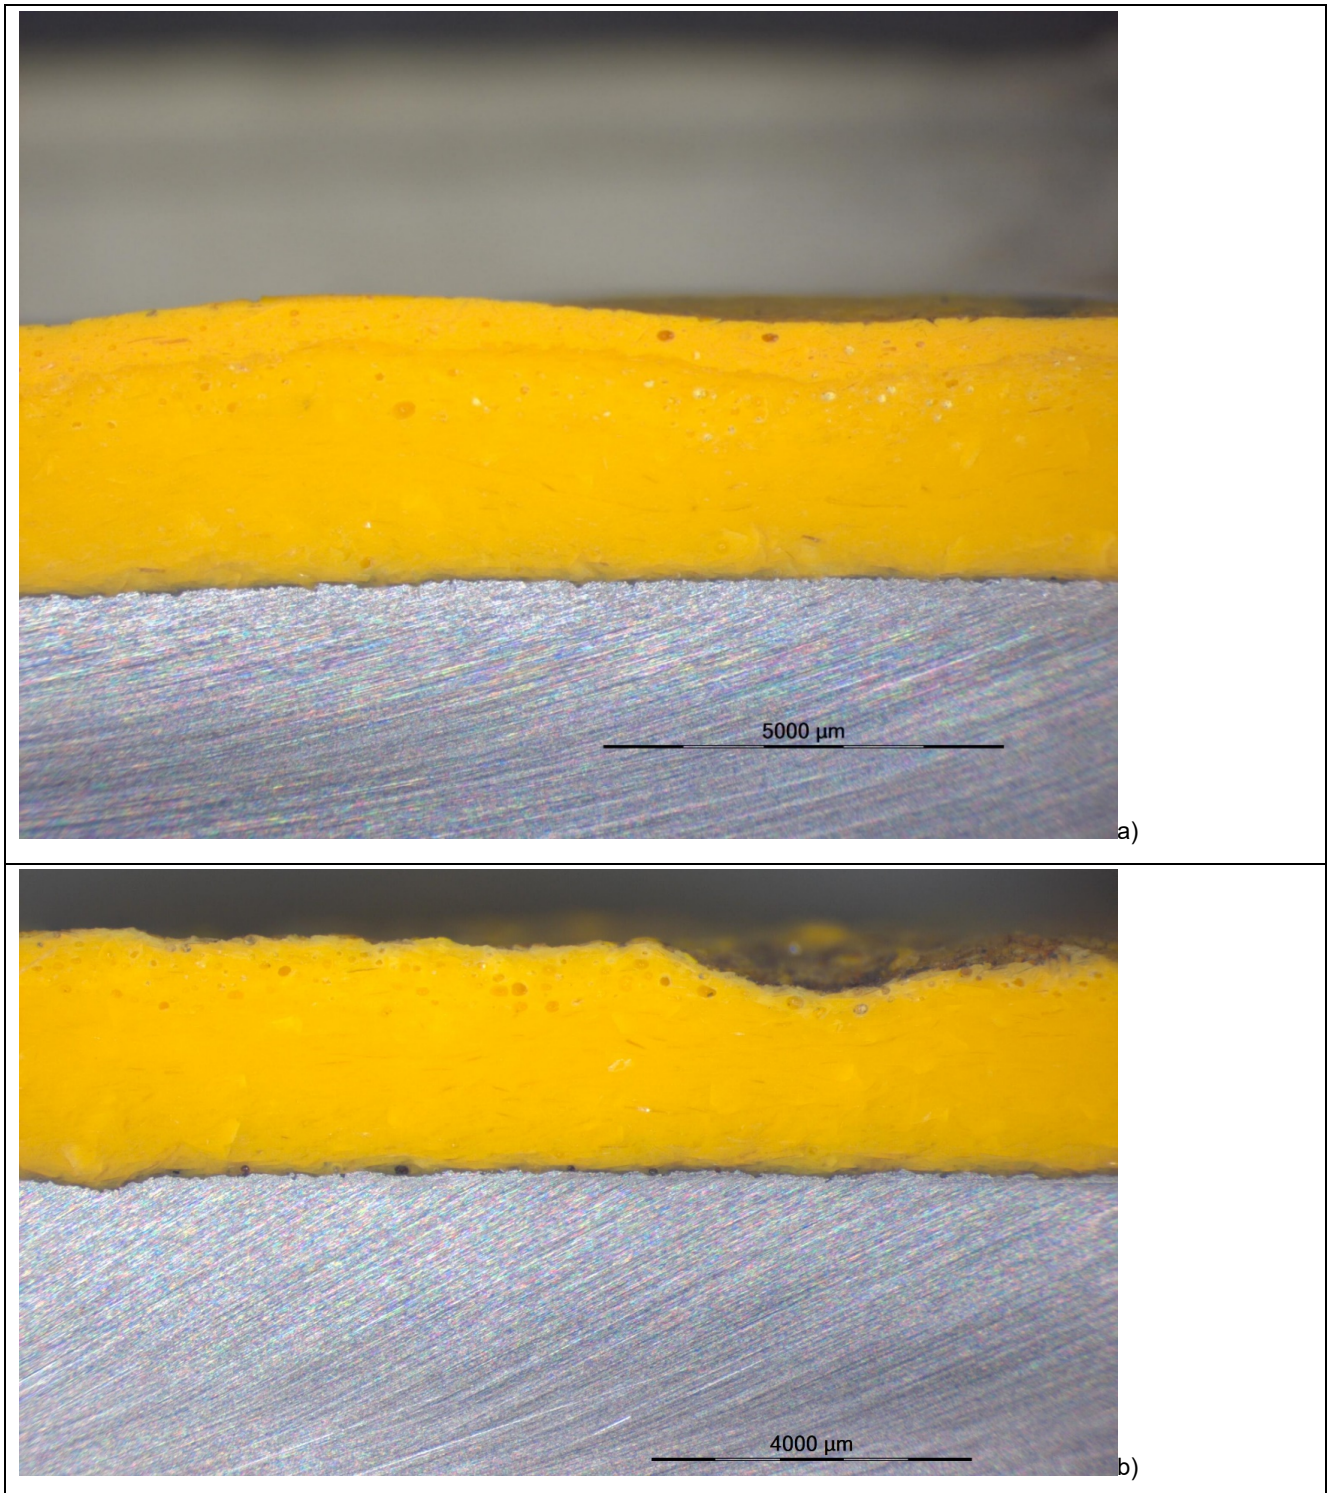
Figure 7-4 a) Cross section of coating at EIS location 1, b) Cross section of coating at EIS location 3, ref. /1/.

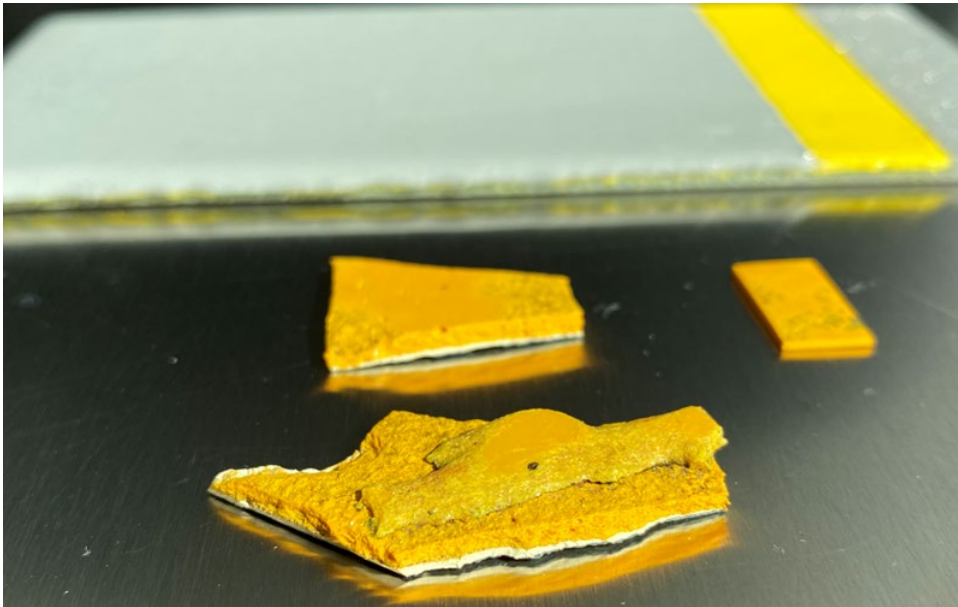
Figure 7-5 Samples for analysis. Yellow rough top layer (with some smooth spillage on one of the samples), white intermediate layer, and a grey primer on some of the samples, ref. /18/.

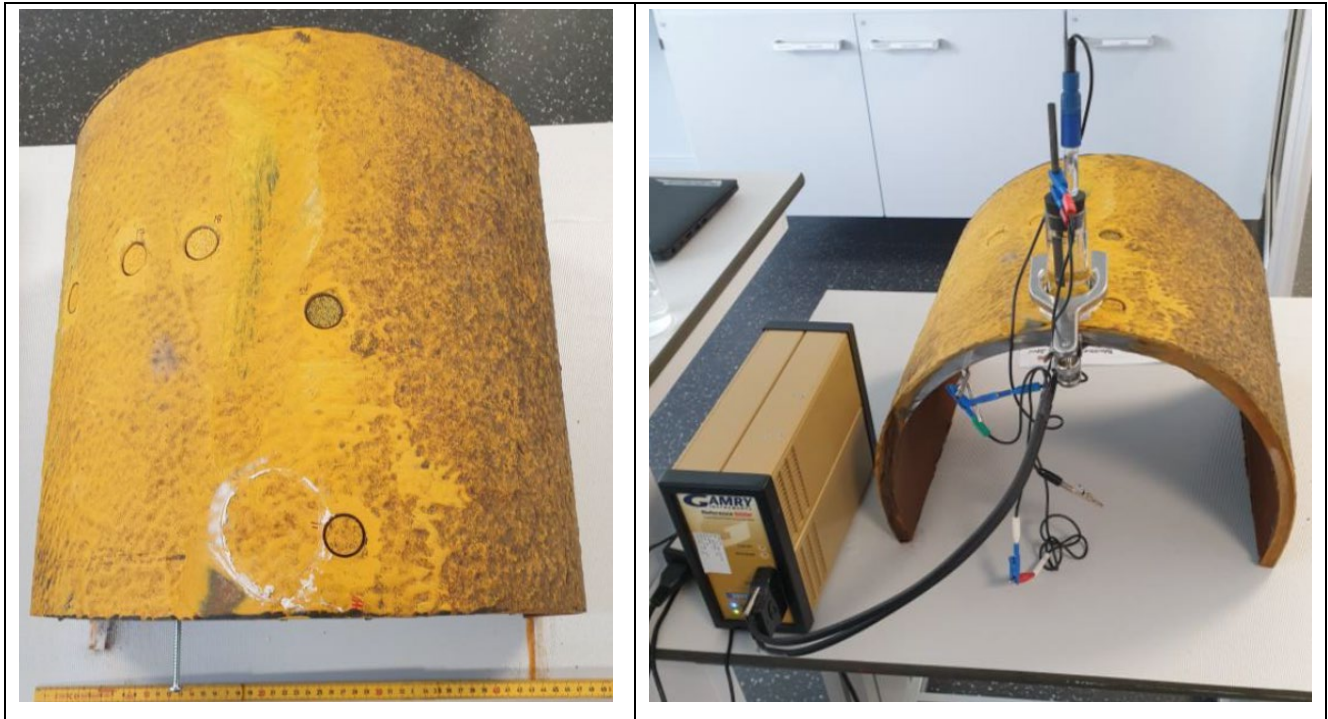
Figure 7-7 As-received sample from 4 m long coated brace in splash zone of EKOA where Jotun A/S carried out EIS measurements. Same sample as shown in Figure 7-1.
