JOTUN - COATING PERFORMANCE LONG TERM EXPOSURE

Splash Zone Coating Performance Long Term Offshore Exposure

Jotun A/S

Report No.: 2021-3194, Rev. 1

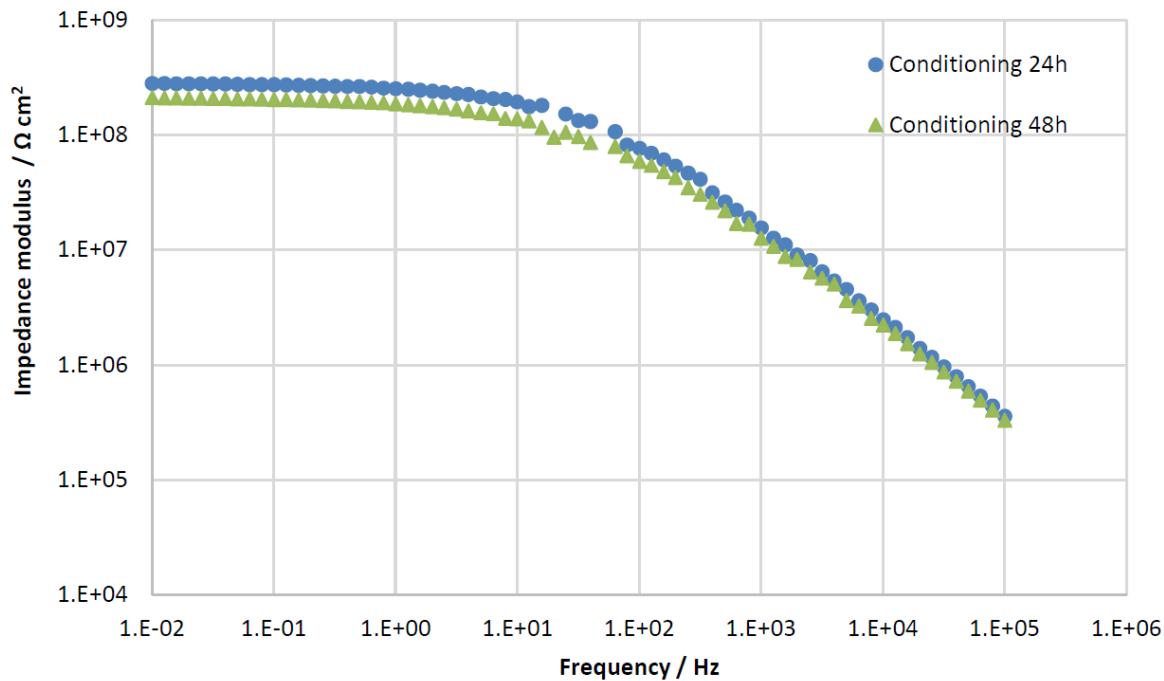
EIS measurements showed close to $3 \times 10^8 \Omega \text{ cm}^2$ at low frequencies (i.e. <10 Hz) after 24 and 48 hours conditioning, see Figure 5-3. The data show according to ref. /5/ a response consistent with an intact coating with no presence of subsurface corrosion phenomena.

Figure 5-3 Bode representation of the EIS data on EKOA topside coating sample after conditioning for 24 and 48 hours in 5 wt% NaCl. Commonly accepted threshold value for coatings is $10^6 \Omega \text{ cm}^2$, ref. /5/.

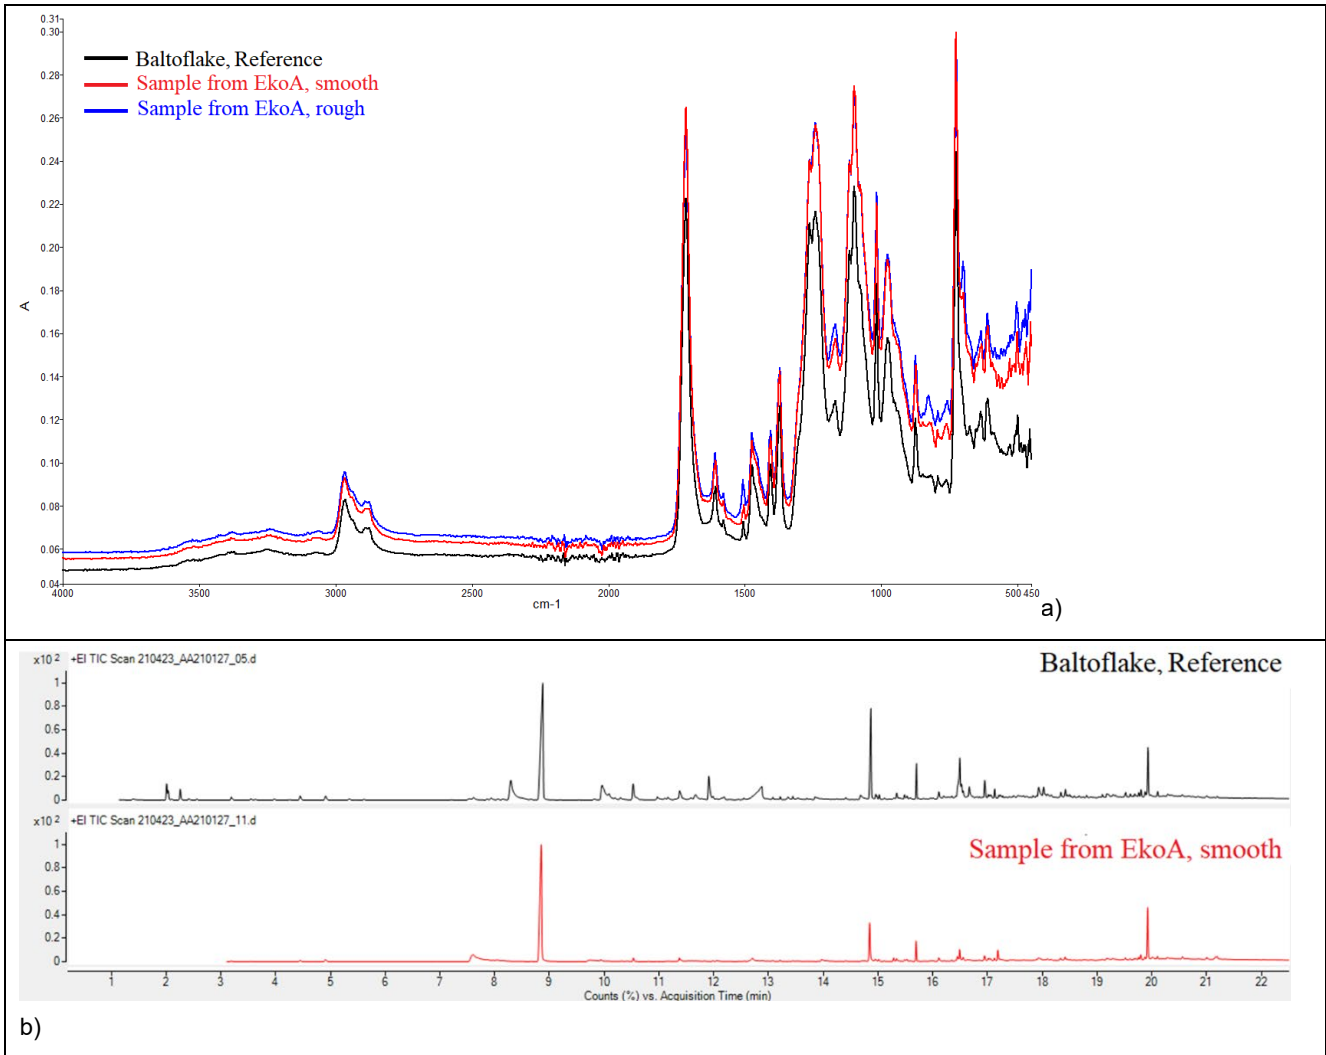
The coating samples shown in Figure 6-5 were analyzed by the use of FTIR, GCMS and SEM in order to establish the chemical composition and the corresponding coating product, ref /18/. Samples analyzed and results are shown in Figure 7-5 and Figure 7-6. It was concluded that the samples mainly comprised of a GFP coating corresponding to Baltoflake. The slight shift in FTIR spectra, see Figure 7-6 indicates that the coating has degraded compared to the reference sample, and deemed to be proof that the sample has been exposed to harsh conditions over a long period of time, ref. /18/. No interlayer adhesion failures were found.

Figure 7-6 a)FTIR spectra of reference Baltoflake and samples from EKO A on two different areas of the yellow outer coating layer. b) GCMS spectra of reference Baltoflake sample and the smooth yellow area of the sample received. Ref. /18/

The formulation of the Baltoflake system has been slightly modified since the versions applied in the 80's/90's, mainly on the chemical composition in order to improve the HSE during application of the system. This is shown in the FTIR analysis of the EKO A samples. The latest version of Baltoflake, Ecolife, is a styrene free version of the GFP. There is no indication that the change of solvent has an impact on the performance of the coating based on long term qualification testing, ref. /23/.

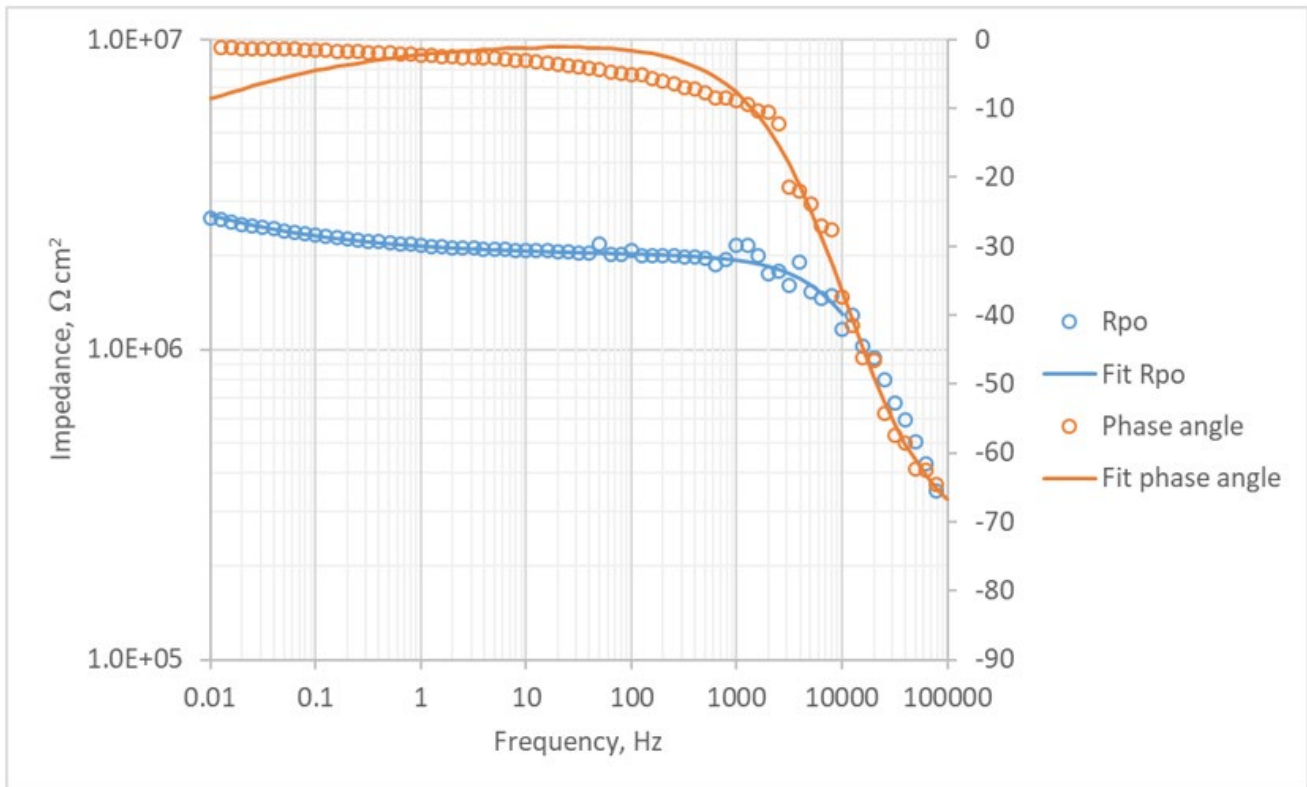
EIS measurements were performed on the sample from the 4 m long length of the coated brace from splash zone of EKO A, see Figure 7-1 and Figure 7-7. The test was carried out according to ISO 16773-2 and following the same set-up as the DNV EIS testing, see Section 7.1. The result is shown in Figure 7-8. The pore resistance was found as $2.0 \times 10^6 \Omega \text{ cm}^2$ and the results suggest according to Ref. /25/ that the coating is intact, with no significant coating degradation. The flattening and slight increase in impedance towards the lower frequency signals water uptake. A good fit of the impedance data was found when utilizing a nested Randles circuit with two constant phase elements, as seen in solid lines (marked “Fit Rpo” and “fit phase angle”) in Figure 7-8.

Figure 7-8 Measured impedance and corresponding phase angle as a function of frequency (Bode plot) after 24 hours conditioning in 5% NaCl solution.
